1. Project Name: Ofu SBH

2. Date of Inspection: March 10, 2005

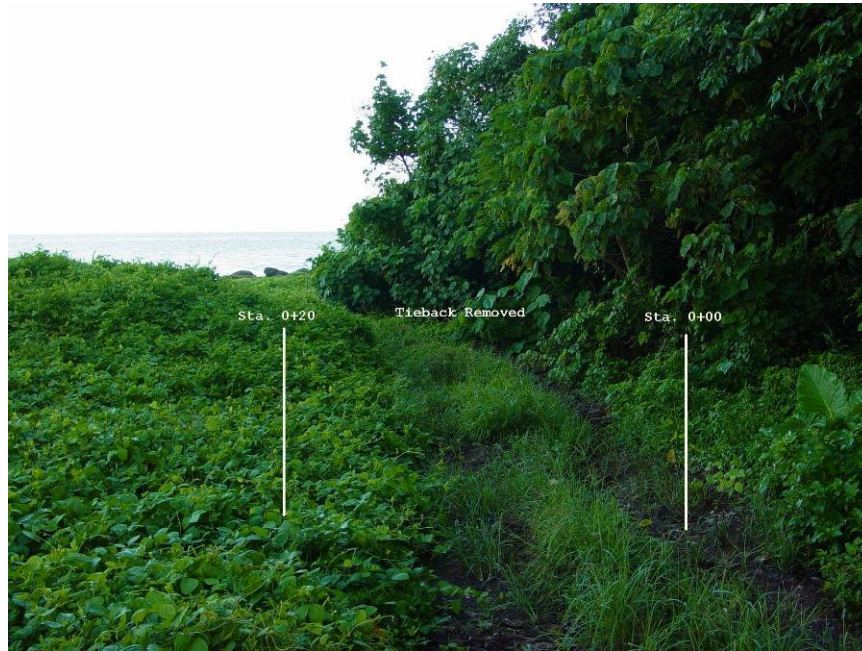
a. Sta. 0+00 to 0+20, armor stones are missing. A road has been cut thru the project creating a gap. Some of the armor stones are stored adjacent the hillside and OS of the structure. Remove vegetation. (2003 Photo)

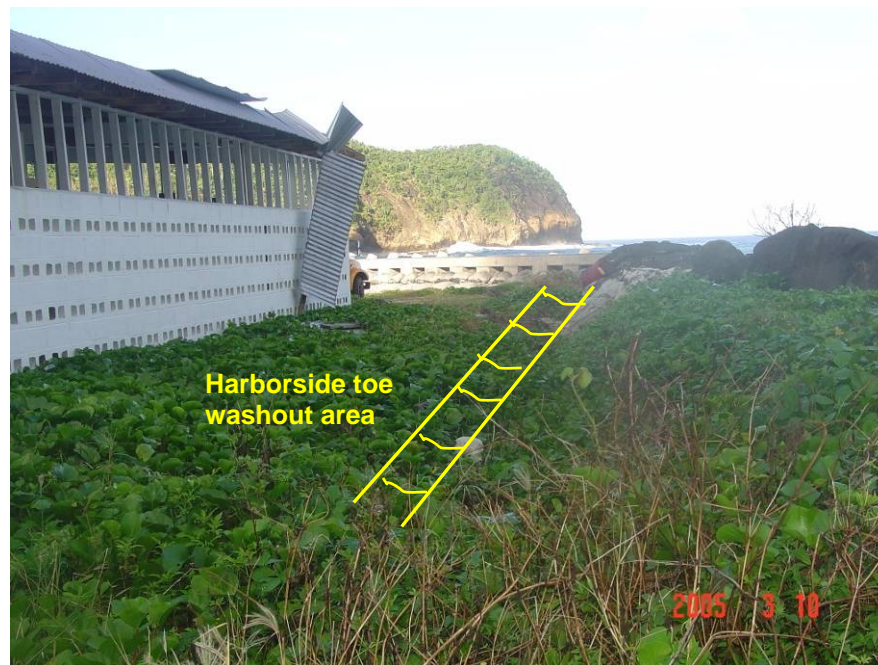
b. Sta 0+00 to 1+60, structure and previously washed out fill area adjacent to harborside toe of the structure are heavily vegetated. Perched armor stones on crest noted in January 2004 post-storm inspection report should be replaced to the 0+00 area, and vegetation removed.

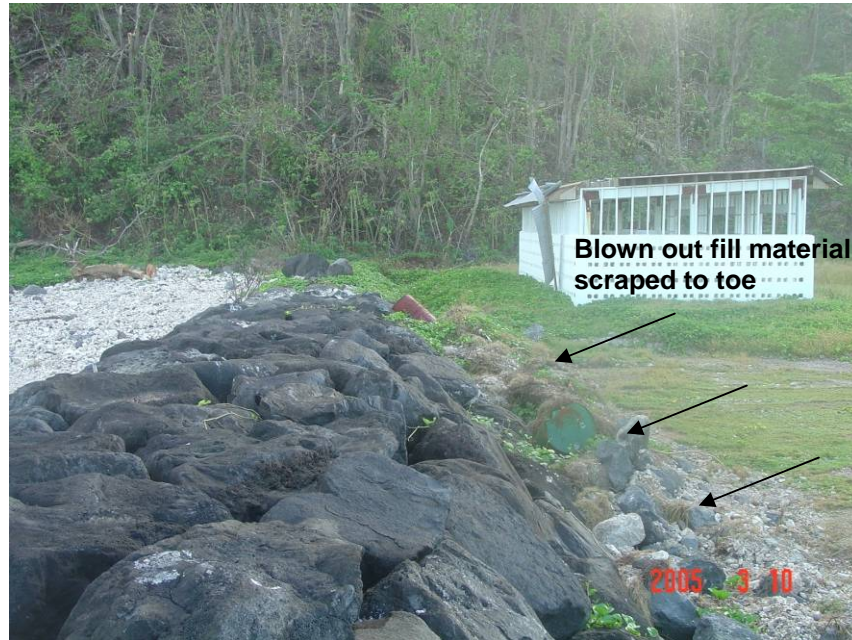
c. Sta 0+00 to 1+60, facing landward. It appears that fill material strewn on land toward harborside of structure after cyclone Heta has been scraped back toward harborside toe of structure.

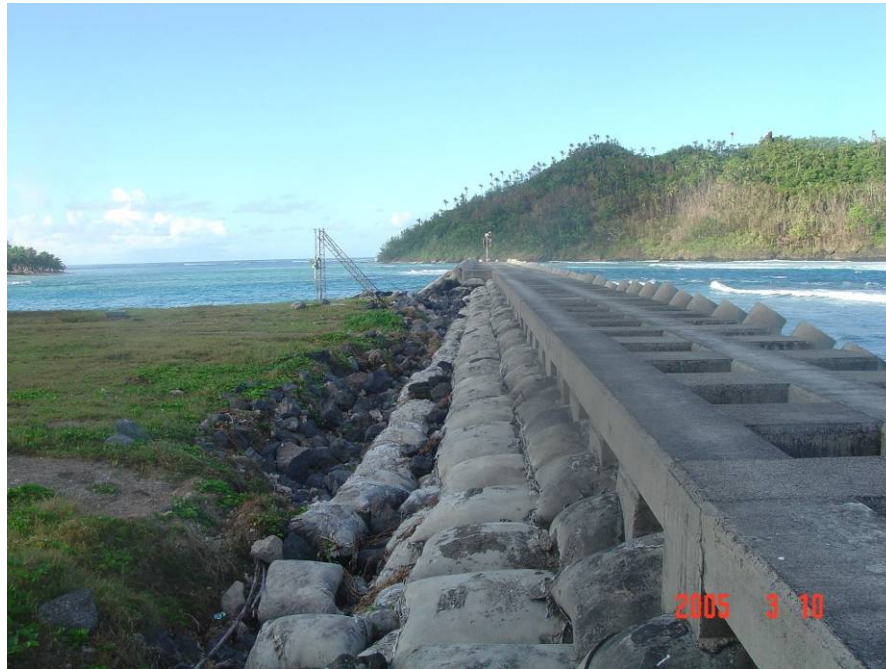
d. Sta 1+75 to Sta. 4+00, HS, Bedding material displaced from harborside toe during Cyclone Heta has been pushed back toward structure. Concrete pillows are still jumbled and bedding material remains exposed.

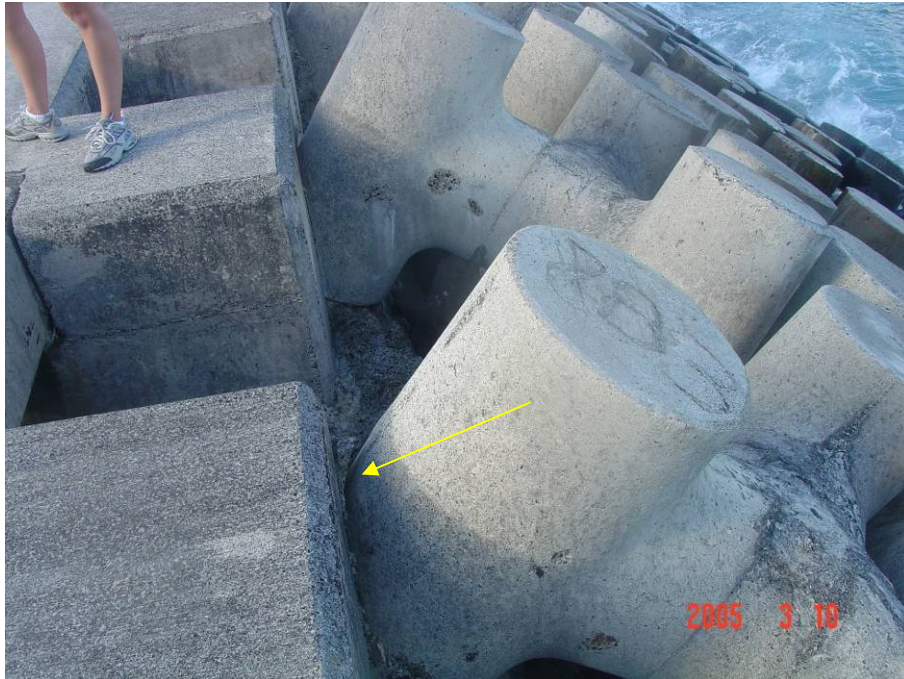
e. Sta 2+47, Rib 12, OS, 2" separation of tribar #883 from ribcap.

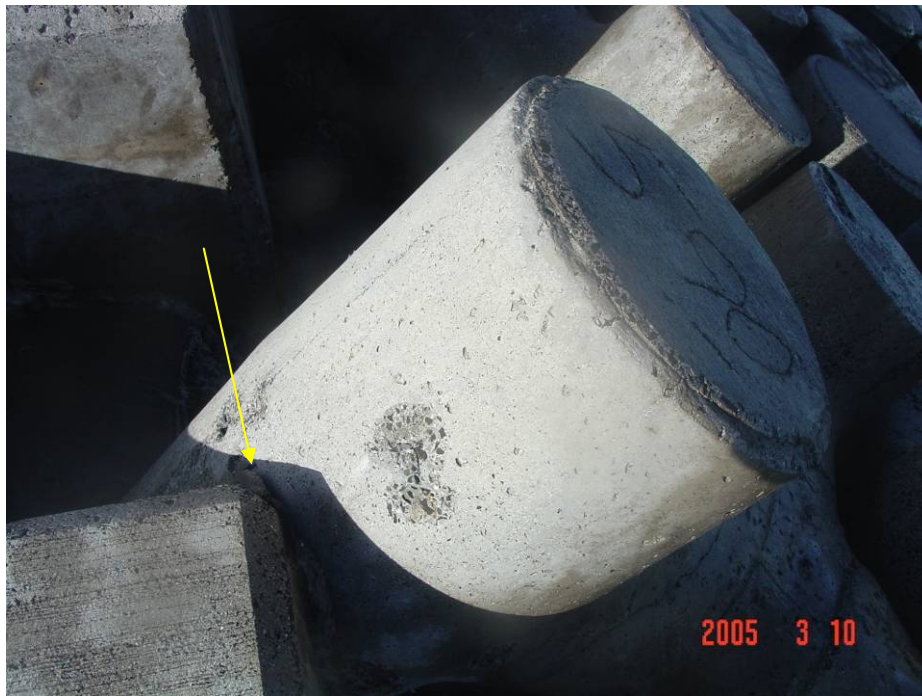
f. Sta. 3+35, Rib # 26 / Tribar # 598, 1 inch separation.

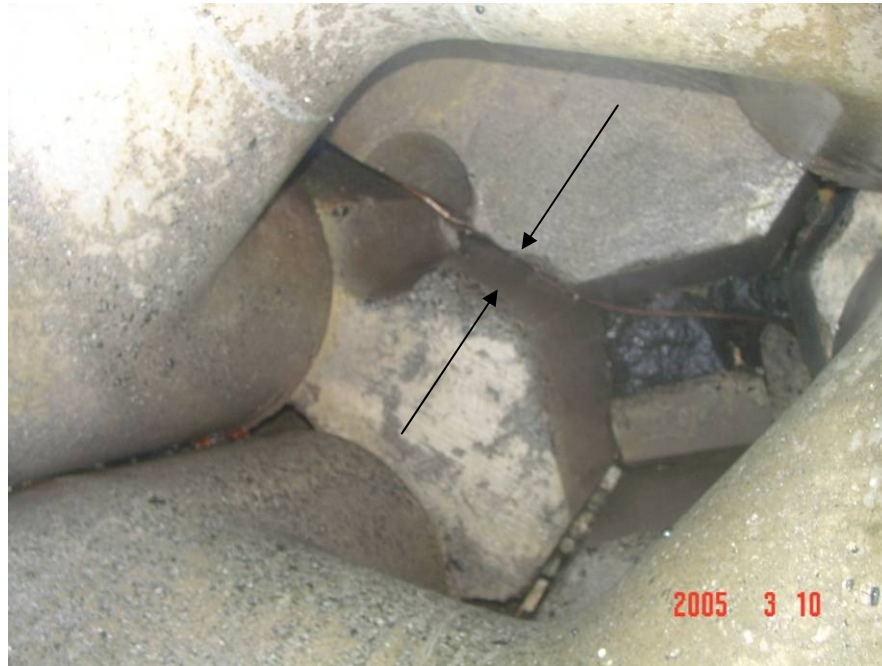
g. Sta. 3+73, OS, 3 in. Cheese block separation beneath Tribar #417

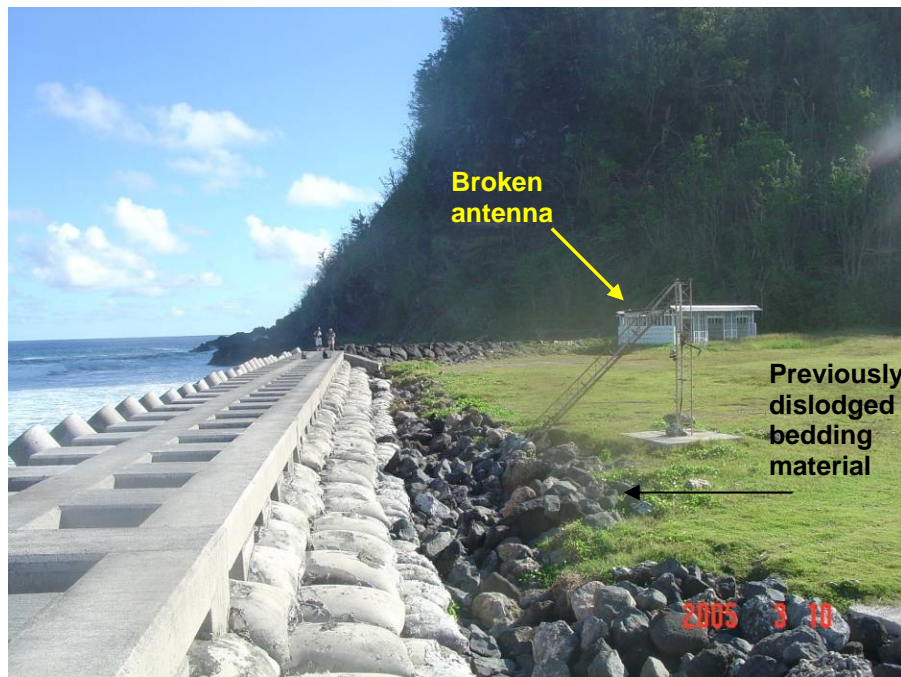
h. Sta. 4+00, Facing landward, note broken antenna and bedding material scraped to toe of structure (Photo for Reference).

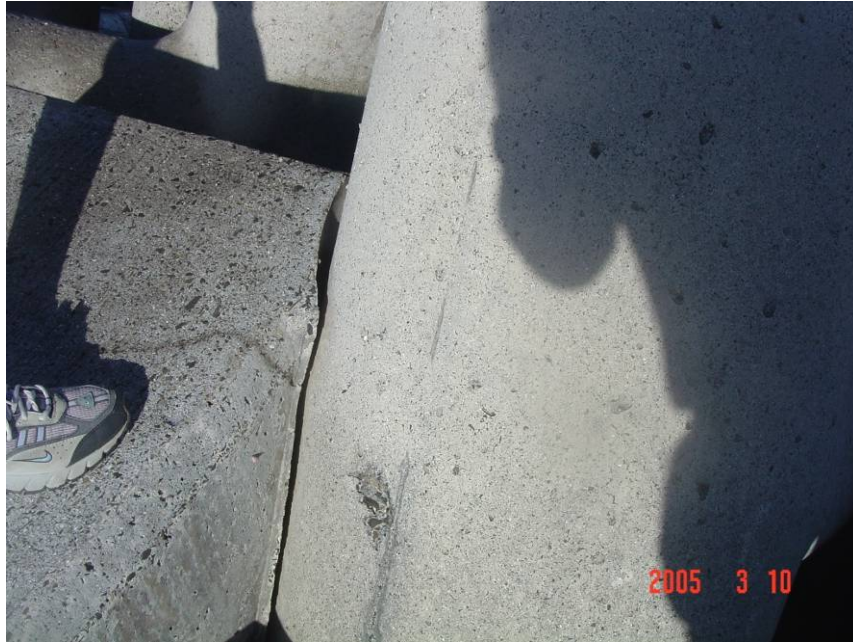
i. Sta. 4+33, OS, Rib # 42 / Tribar # 771, 1 inch separation.

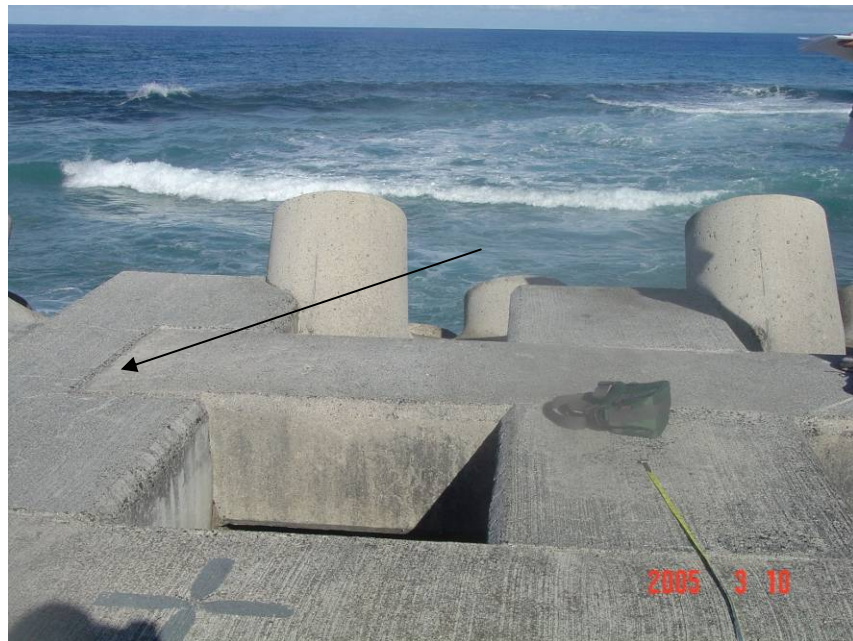
j. Sta. 4+39, OS, Rib # 44, Construction Joint (Photo for Reference).

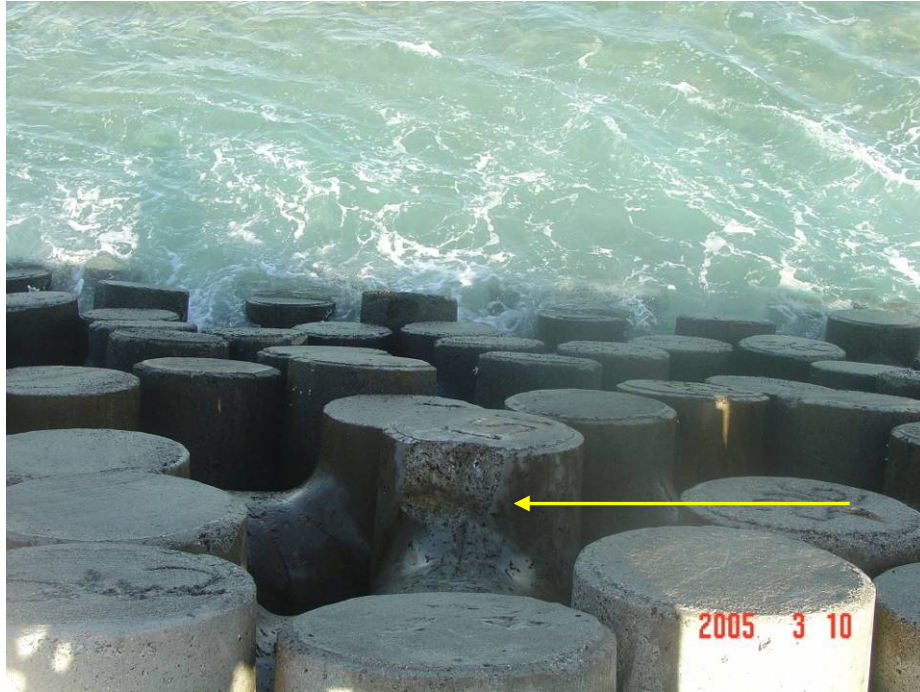
k. Sta. 4+66, OS, Chipped Leg on Tribar # 151.

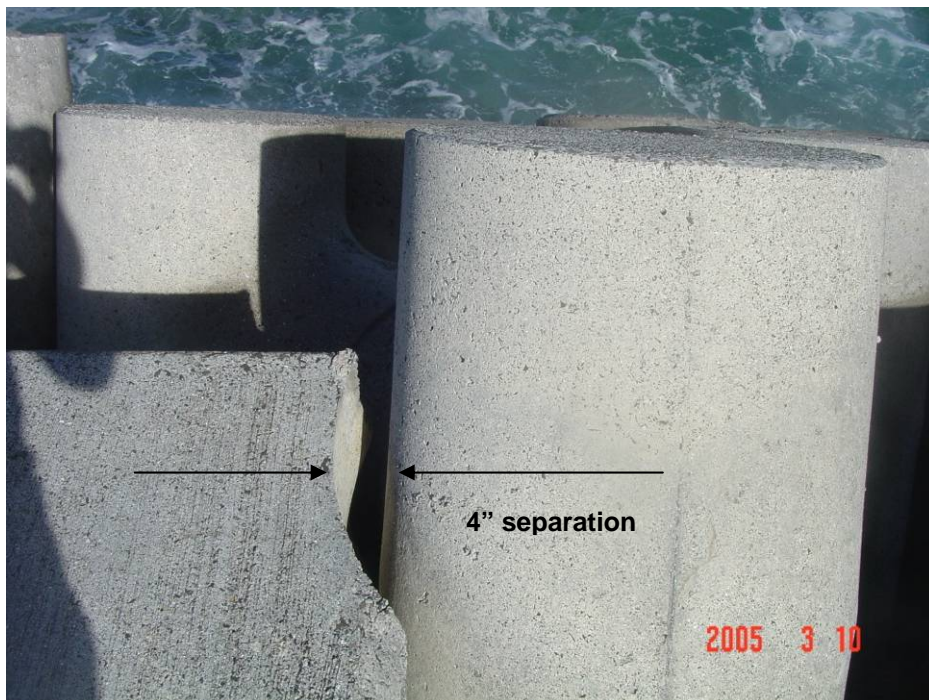
l. Sta. 5+71, OS, Rib # 65 / Tribar # 678, 4 inch separation.

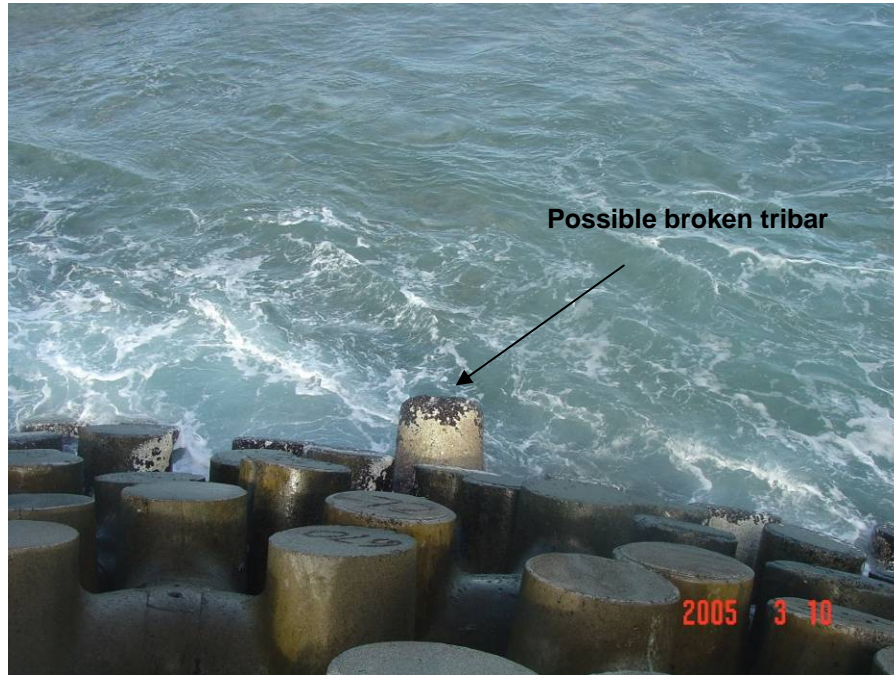
m. Sta. 6+05, OS, possible dislodged or broken tribar.

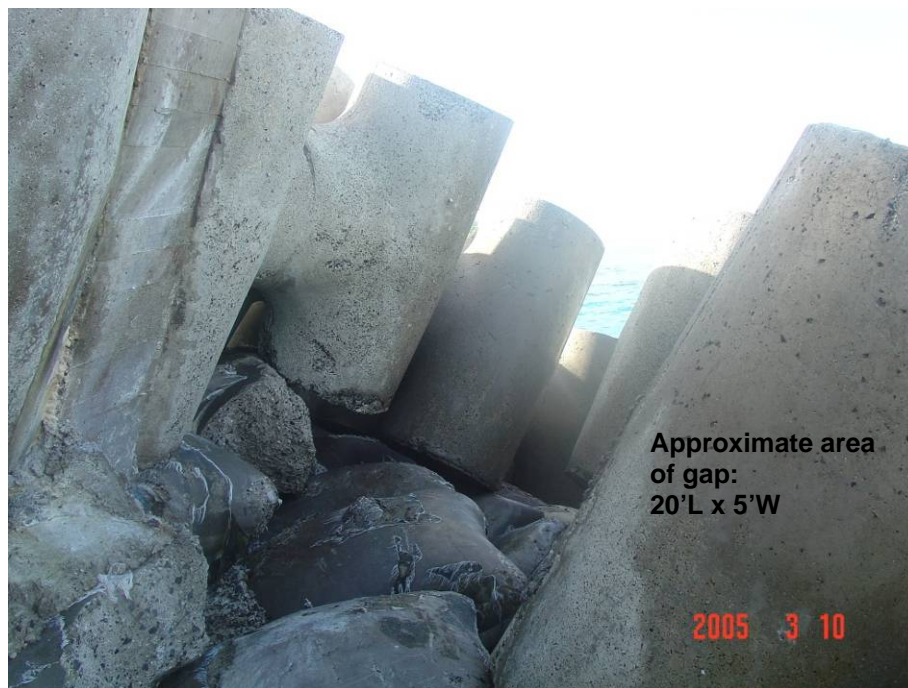
n. Sta. 6+10, Head, Approximately 3 tribars have been washed out adjacent to the ribcap.

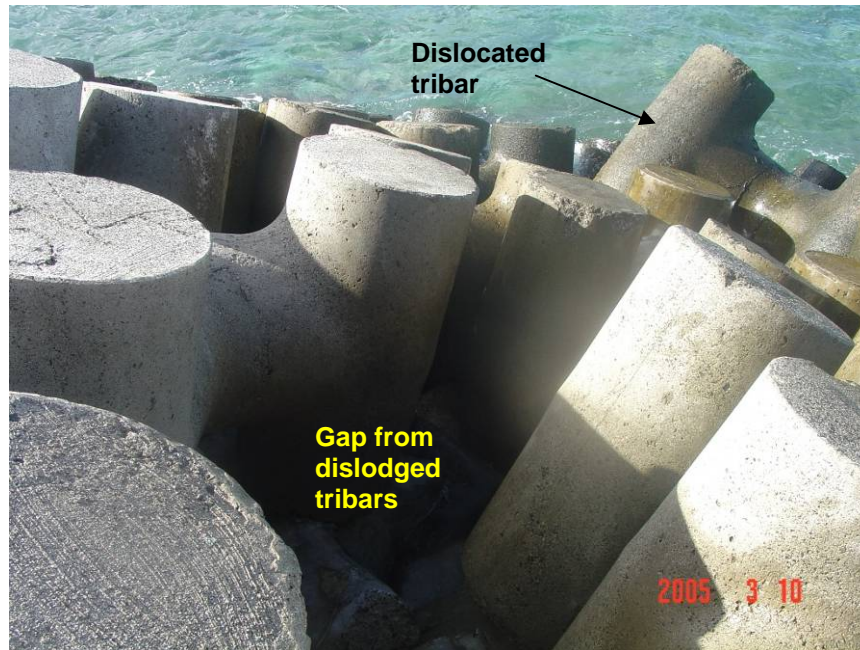
o. Sta. 6+10, Head, Gap on OS of head from missing tribar. One of the dislocated tribars in background.

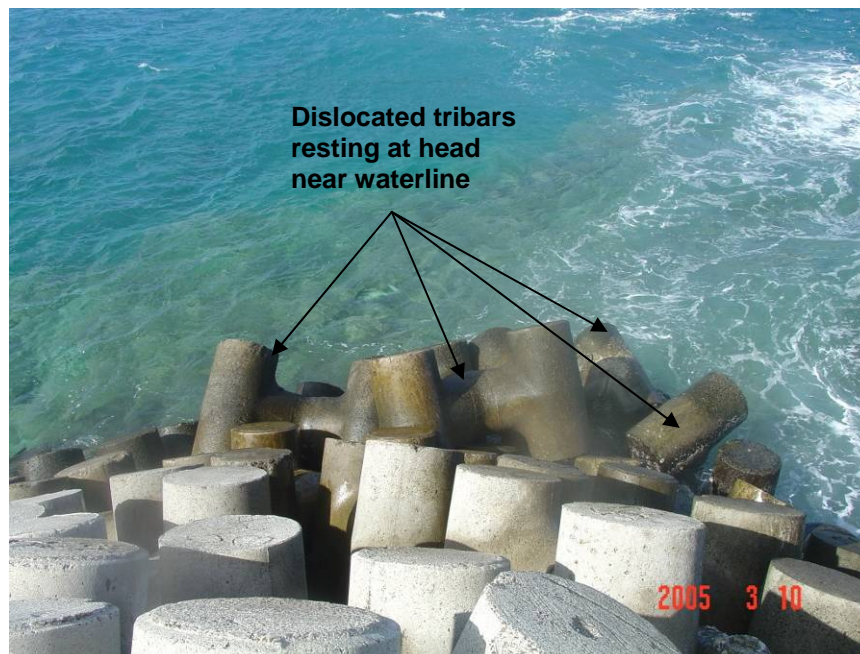
p. Sta. 6+10, Head at centerline, 4 dislocated tribars resting at toe of the structure.

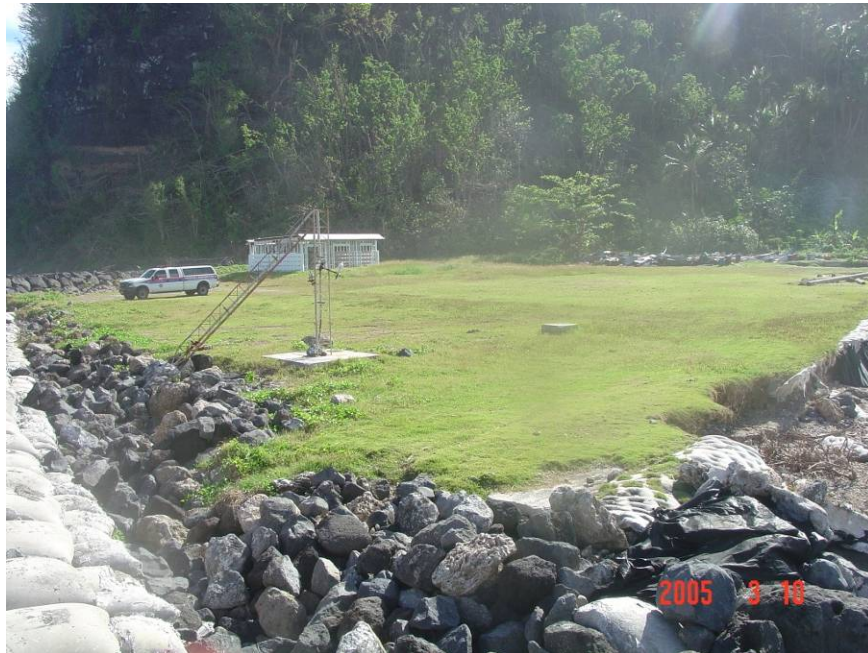
- s. Land area adjacent to breakwater has been cleared of debris and bedding material.

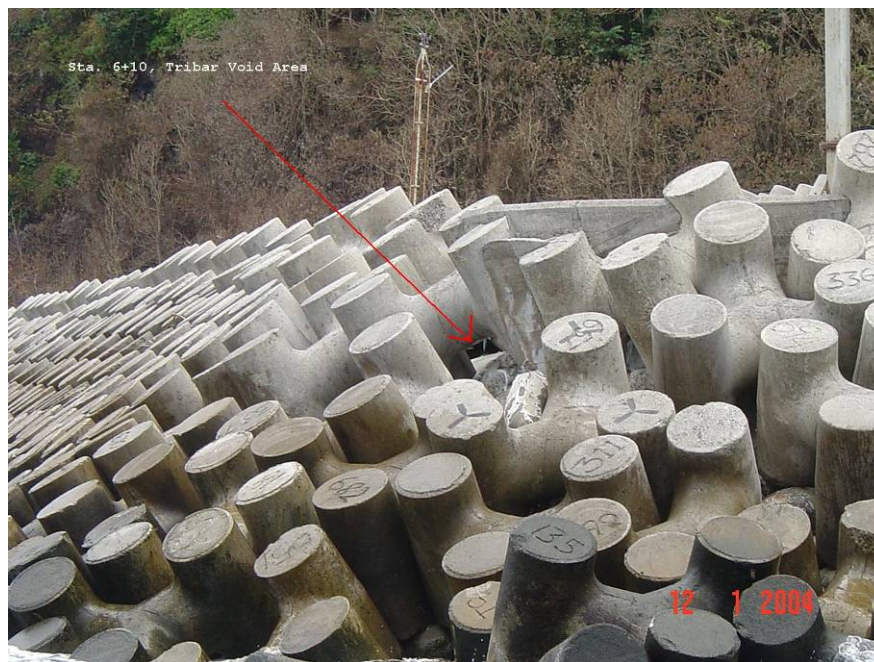
- t. Sta 6+10, View of tribar void area at head from water. (2004 Photo)

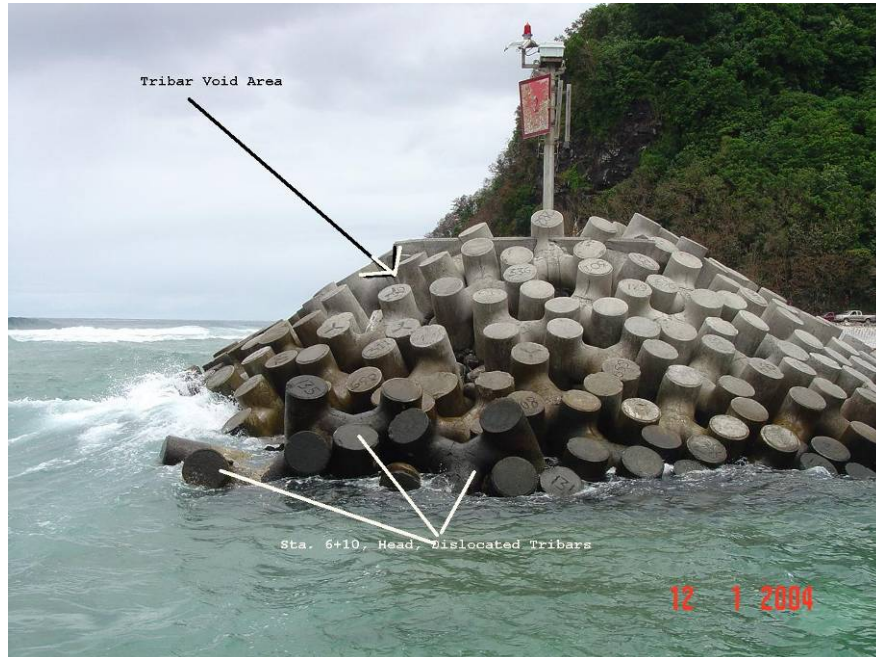
u. Head, view of displaced tribars and void from water. (2004 Photo)

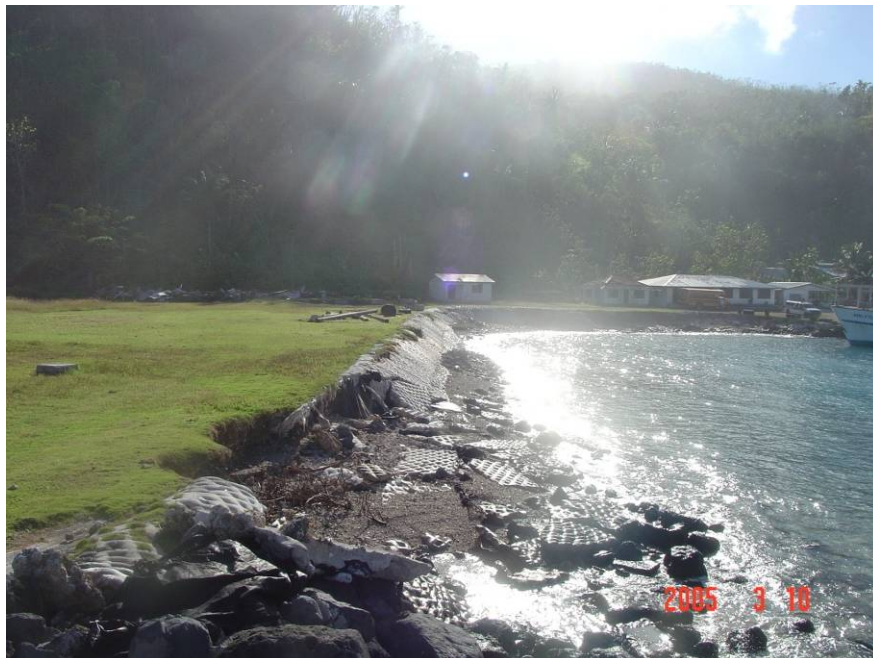
Damages to locally maintained interior revetment at harbor.

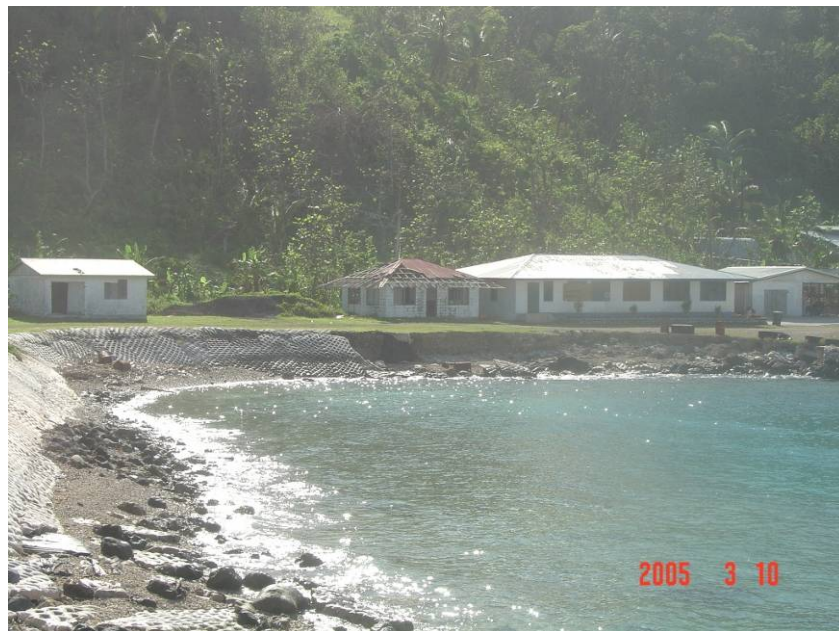
Damage to non-Federal interior revetment at harbor.
